Determination of the crack propagation direction of fractured ductile cast iron based on the characteristic features of the surface

D.Fernandino^{1*}, R.Boeri¹

¹Metallurgy Division, National University of Mar del Plata
INTEMA- CONICET, Mar del Plata, Argentina

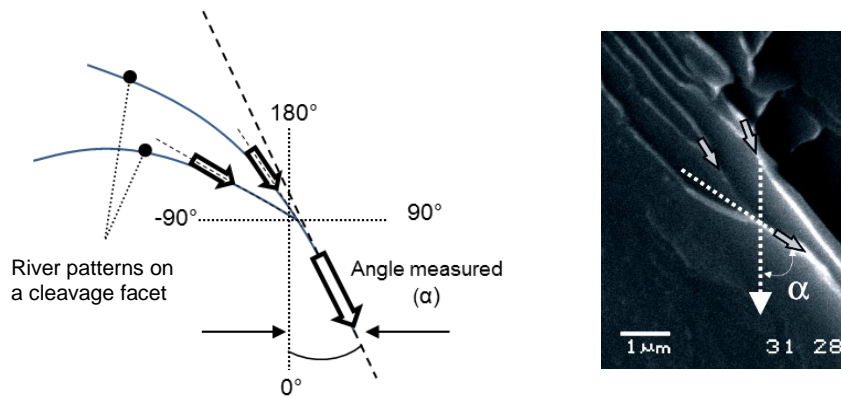
The literature reports that the river patterns present on the cleavage facets converge into a single crack following the direction of the local crack propagation. Therefore, it should be possible to assess the main crack direction through the observation of the propagation on the cleavage planes or facets. The approach used in this study was to identify and to characterize the local propagation direction by means of the observation of the directions of the river patterns with respect to the main crack propagation direction, which is known. The methodology proposed used a local propagation vector that is defined at the point in which two river patterns join, as shown in Fig. 6. All measured local propagation vectors were characterised by the angle formed with respect to the main crack propagation direction. The large number of values of local angles measured were averaged and the resulting direction compared to the main crack propagation direction. In all situations, the main crack propagation direction was set at 0°.

Fig. 6. Method used to define a local propagation vector on the cleavage fracture surfaces resulting of impact and bending test.

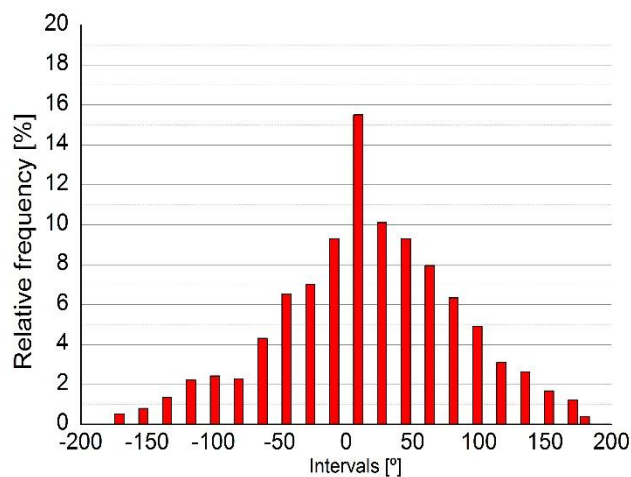
The results of the statistical dataset are listed in Fig. 7. The mean value (\bar{X}) of the dataset was 9 ± 2 and the mode value (M_o) of the distribution was 0° . These results not only show that the average of local propagation vectors reveals the predominant propagation direction with good accuracy, but also, a higher relative frequency was observed for the directions with little deviation from the main crack propagation. The local directions were grouped into 20 intervals ranging from -180° to 180° in concordance with the reference system used in the present methodology. A number of 1515 local crack propagation direction was analysed in five different fracture surface area.

Fig. 7. Histogram obtained from the quantitative analysis on SEM fractographies of FI-20 sample.

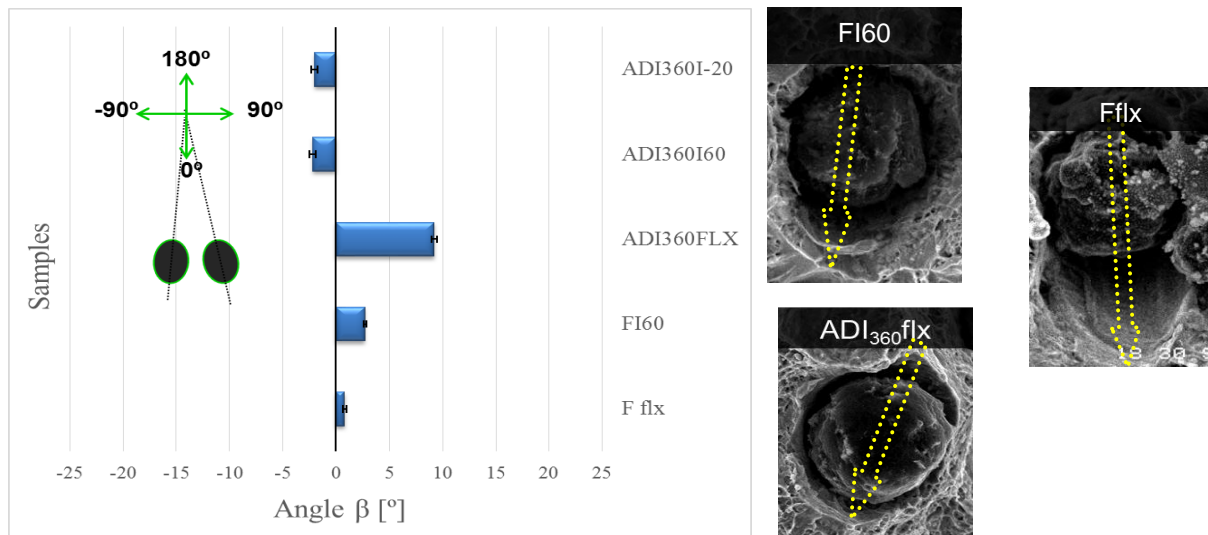
Fig. 10. Plot from the experimental measurements of angle β
